Effects of bank vegetation in waterways with special reference to bank erosion, shear strength, root density and channel hydraulics

**Effects of Bank Vegetation in Waterways with Special
Reference to Bank Erosion, Shear Strength, Root Density and
Channel Hydraulics**

**A thesis submitted to the Open University
for the Degree of Doctor of Philosophy
Biology Department
September 1992**

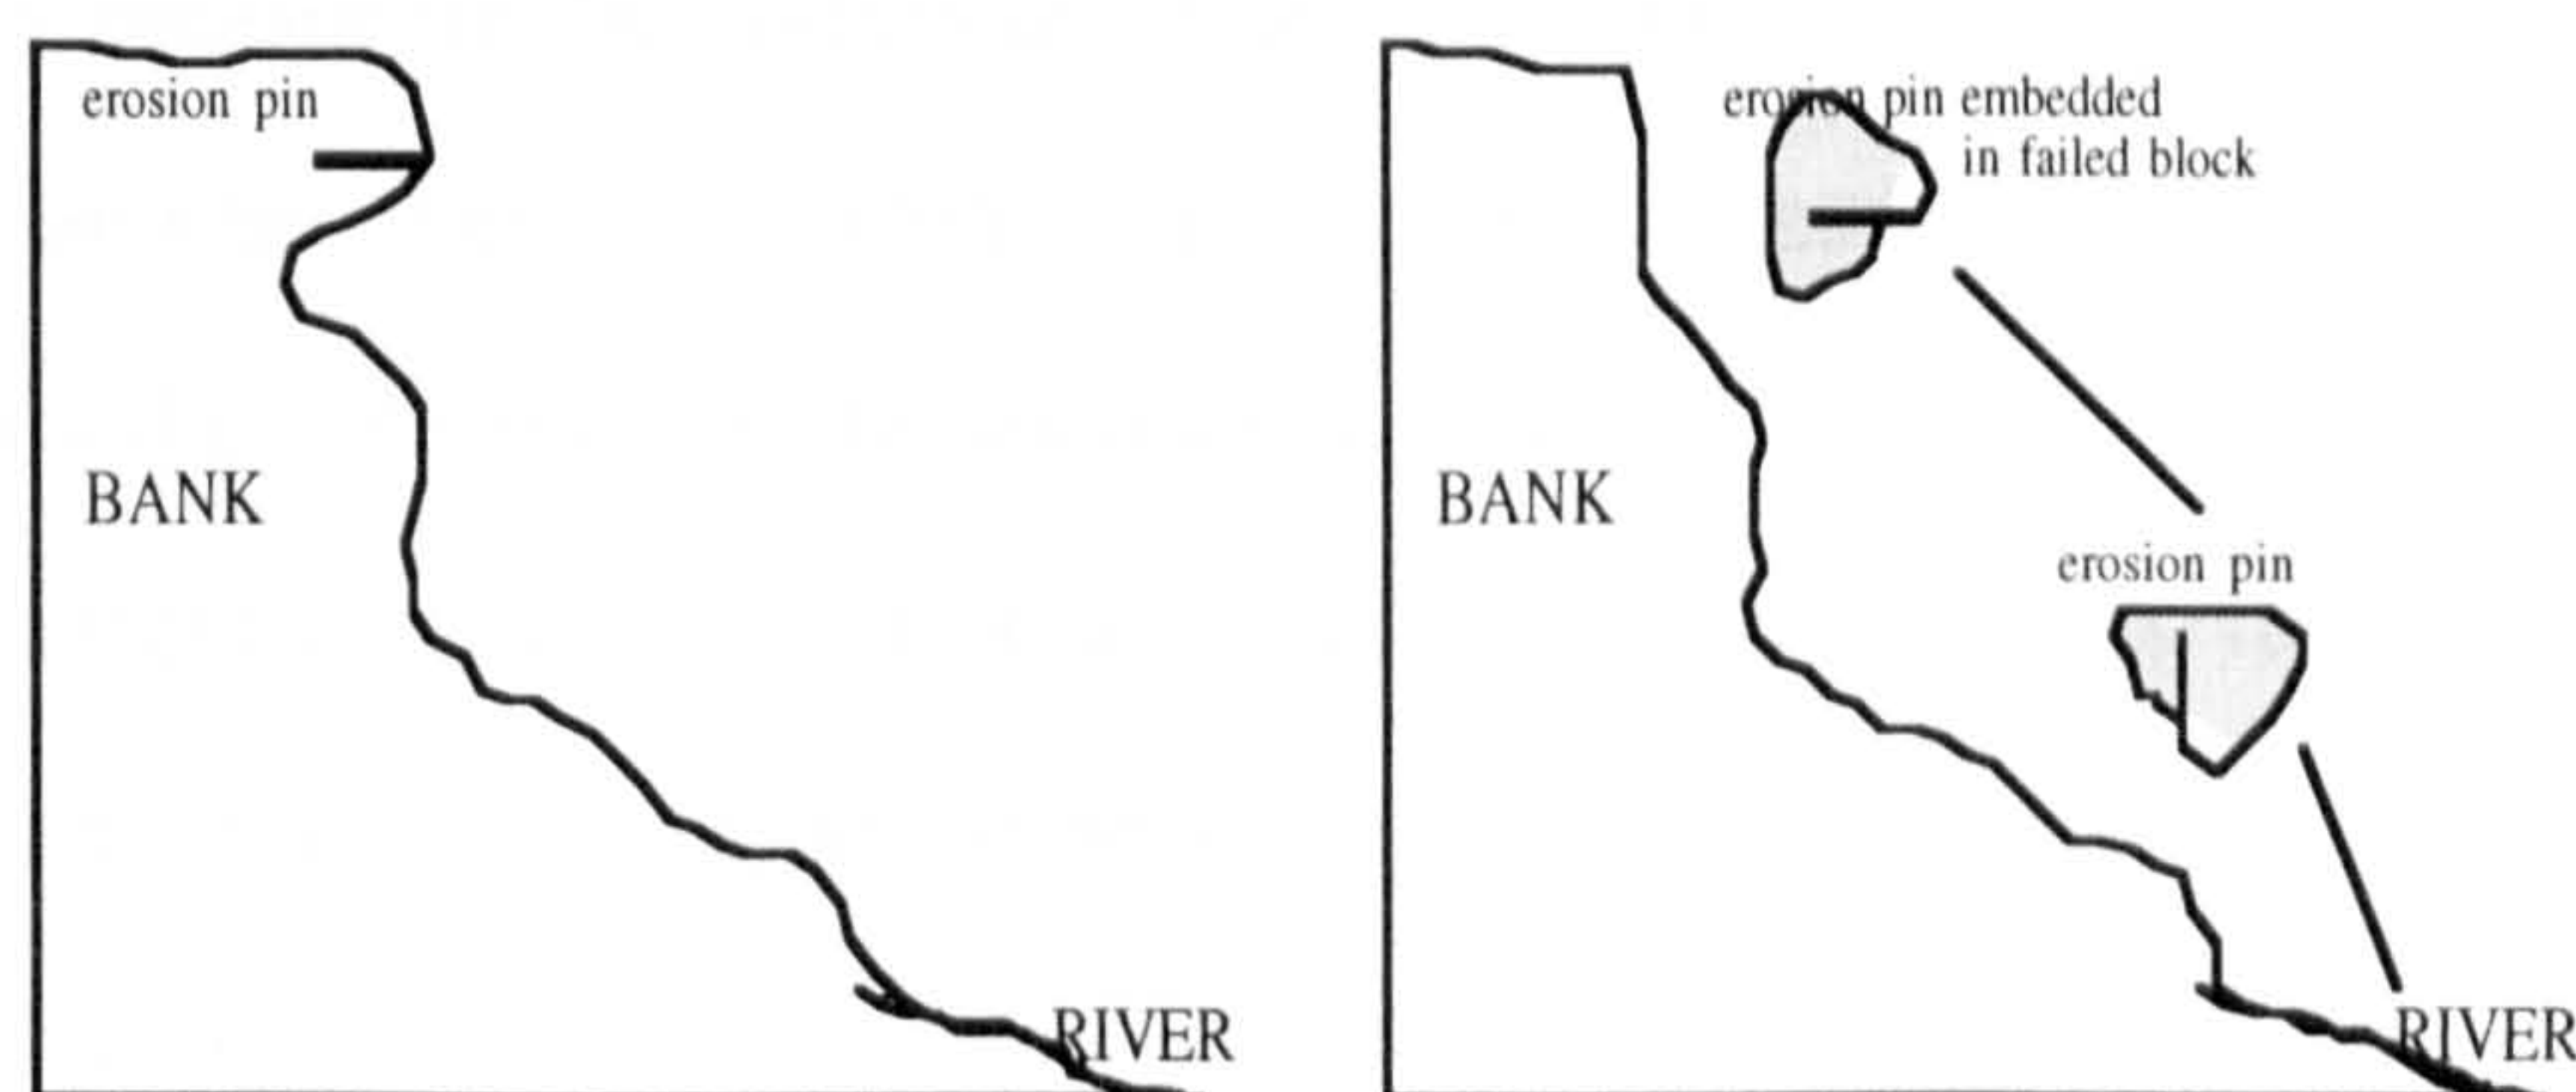
Fig. 2.10 :Loss of erosion pin during mass failure

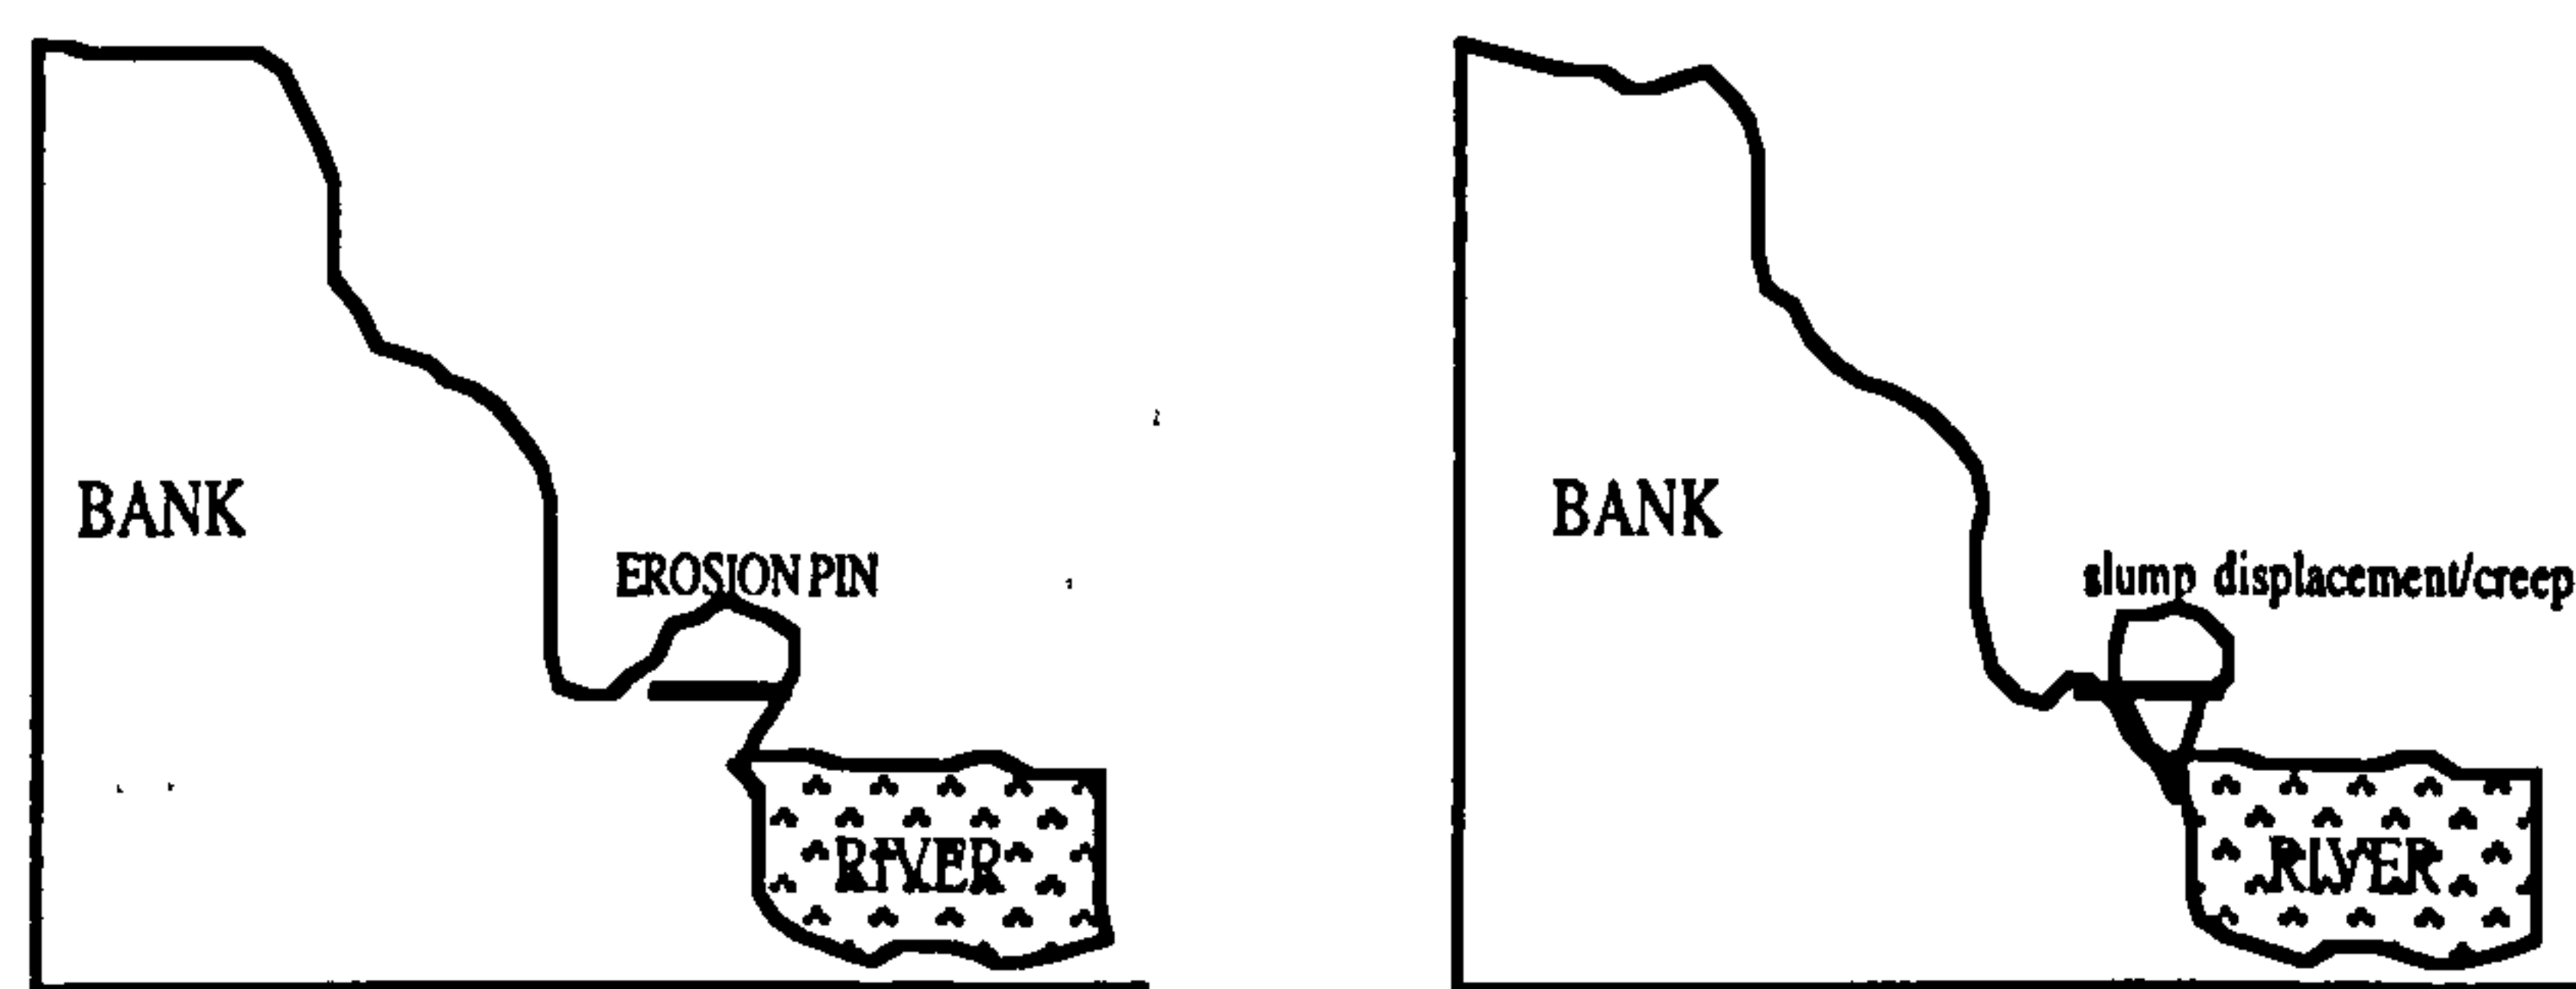
Fig. 2.11 : Slump displacement and associated error in pin technique

Another disadvantage of the erosion pin technique is soil creep and surficial crack deepening with a pin embedded in the slump (Fig.2.11) leading to false readings.

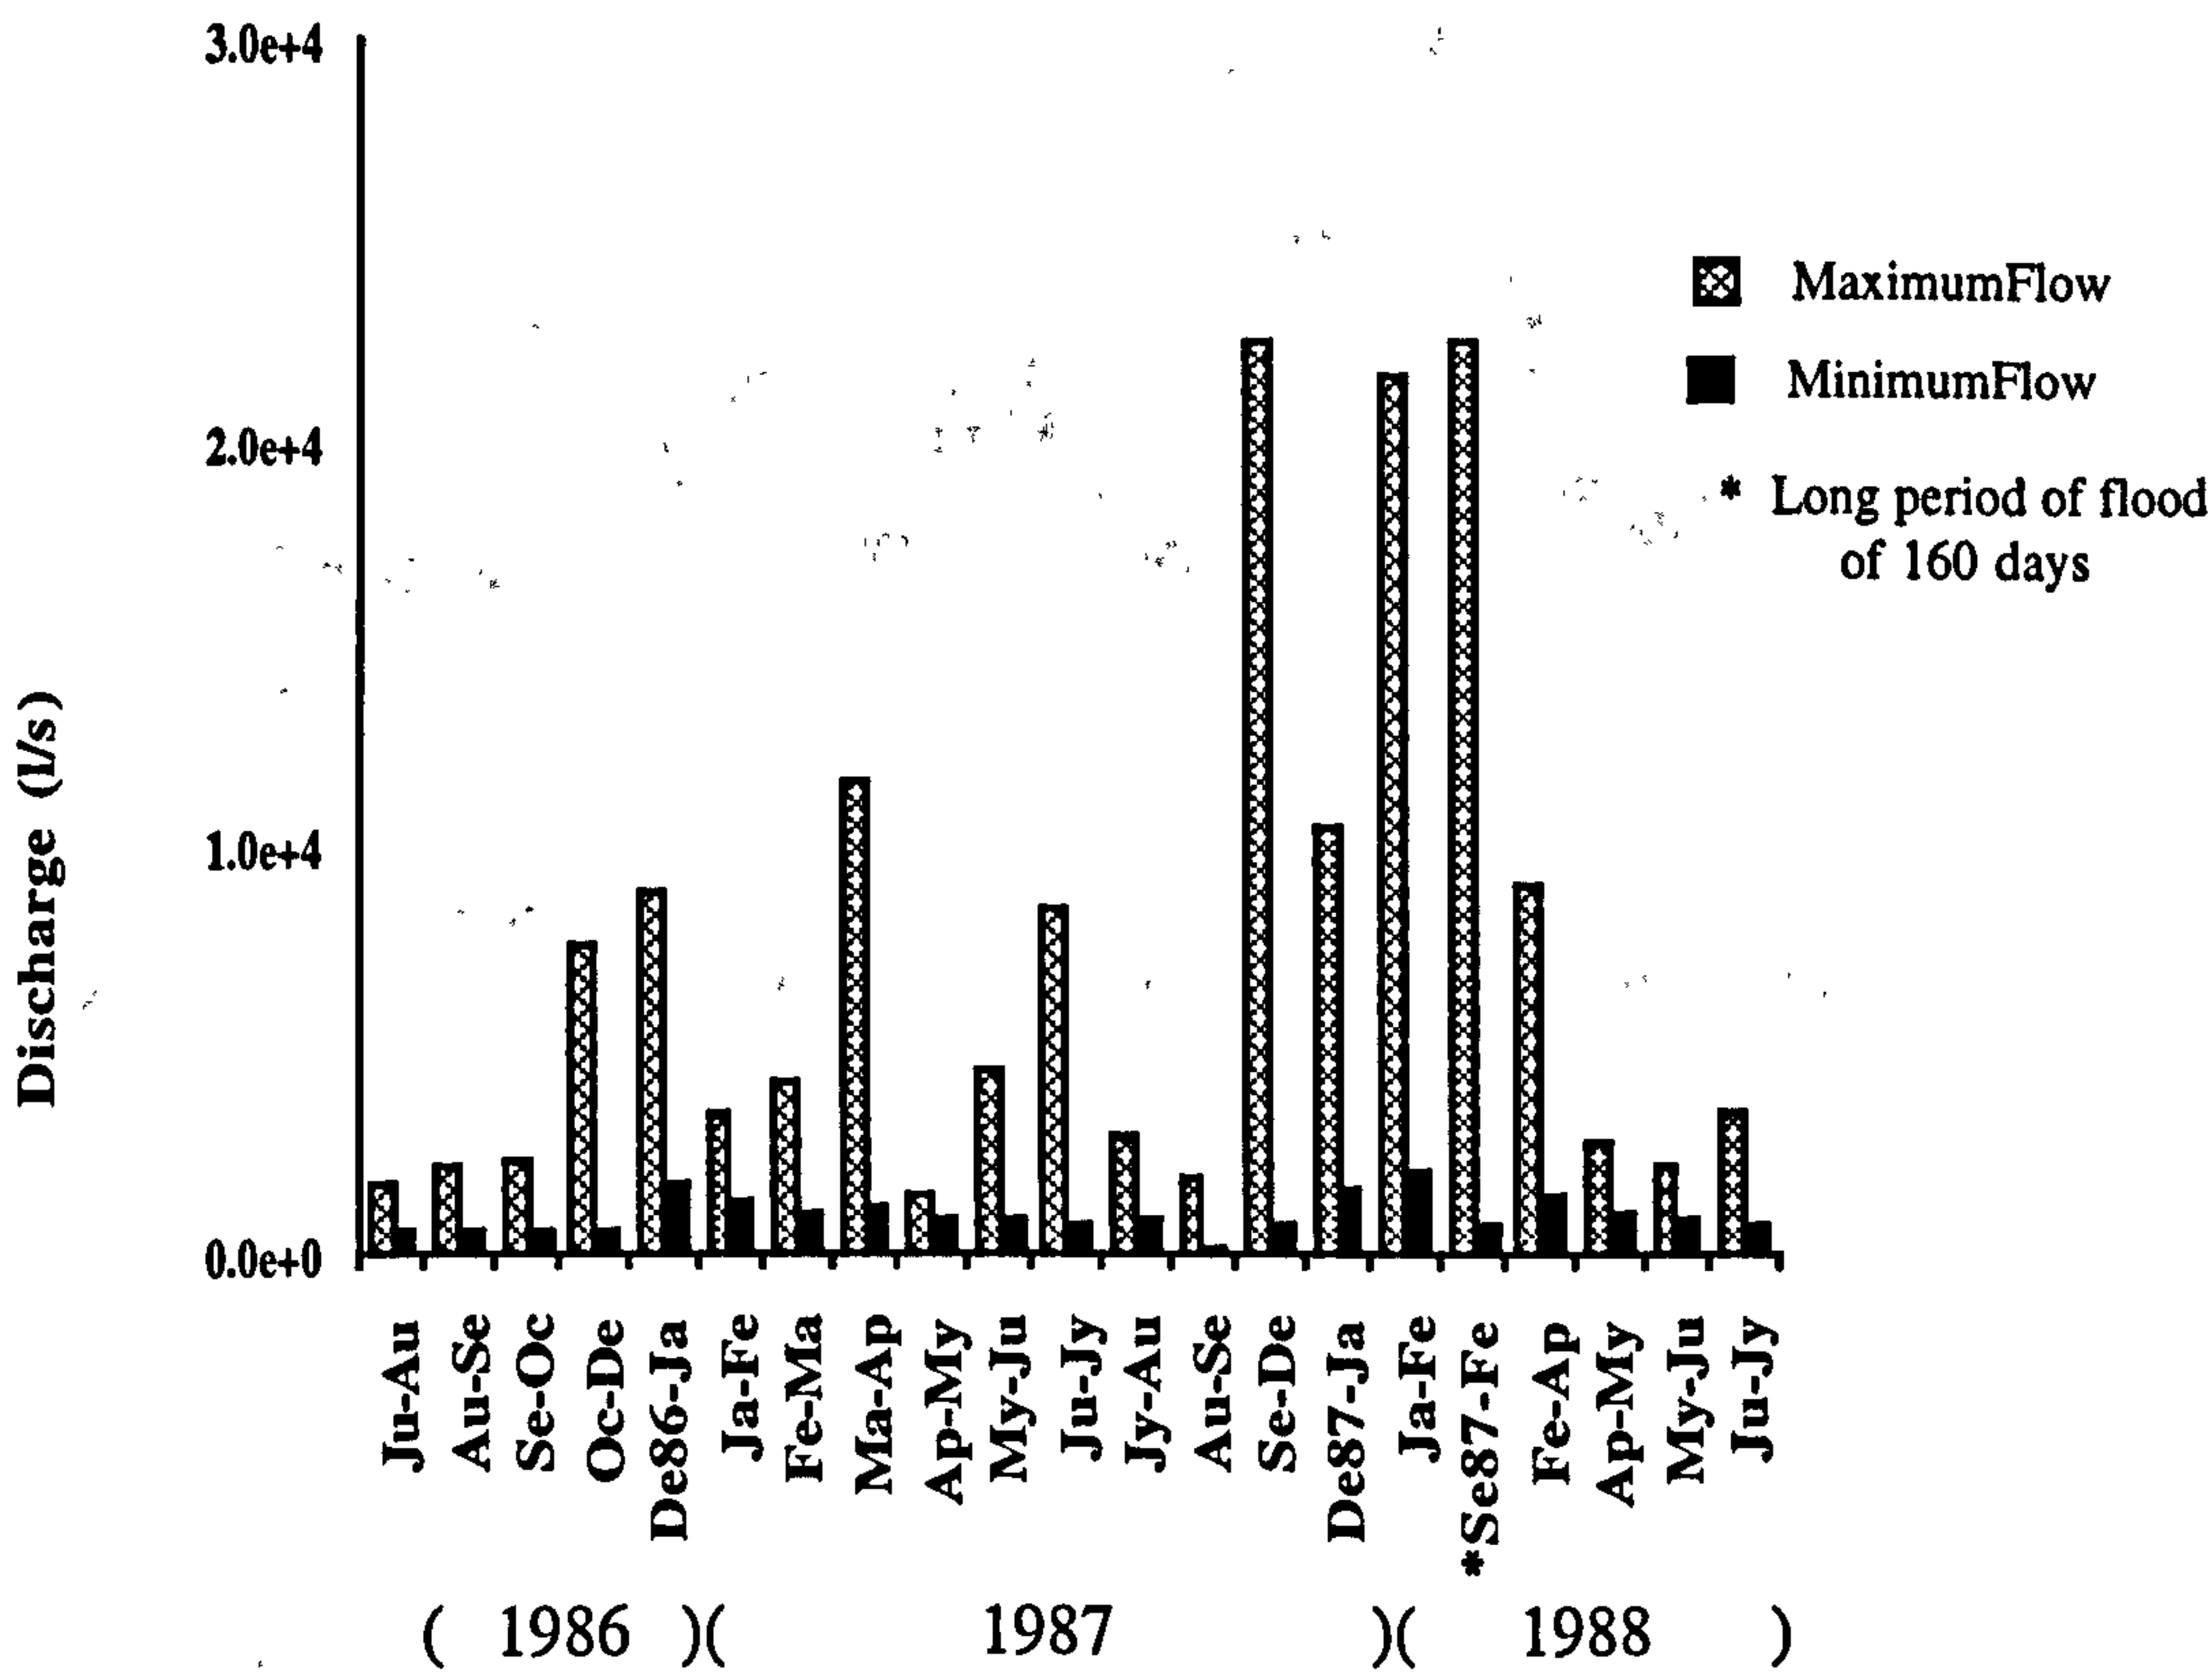
Fig. 3.1a : Maximum and minimum discharge during period of erosion.

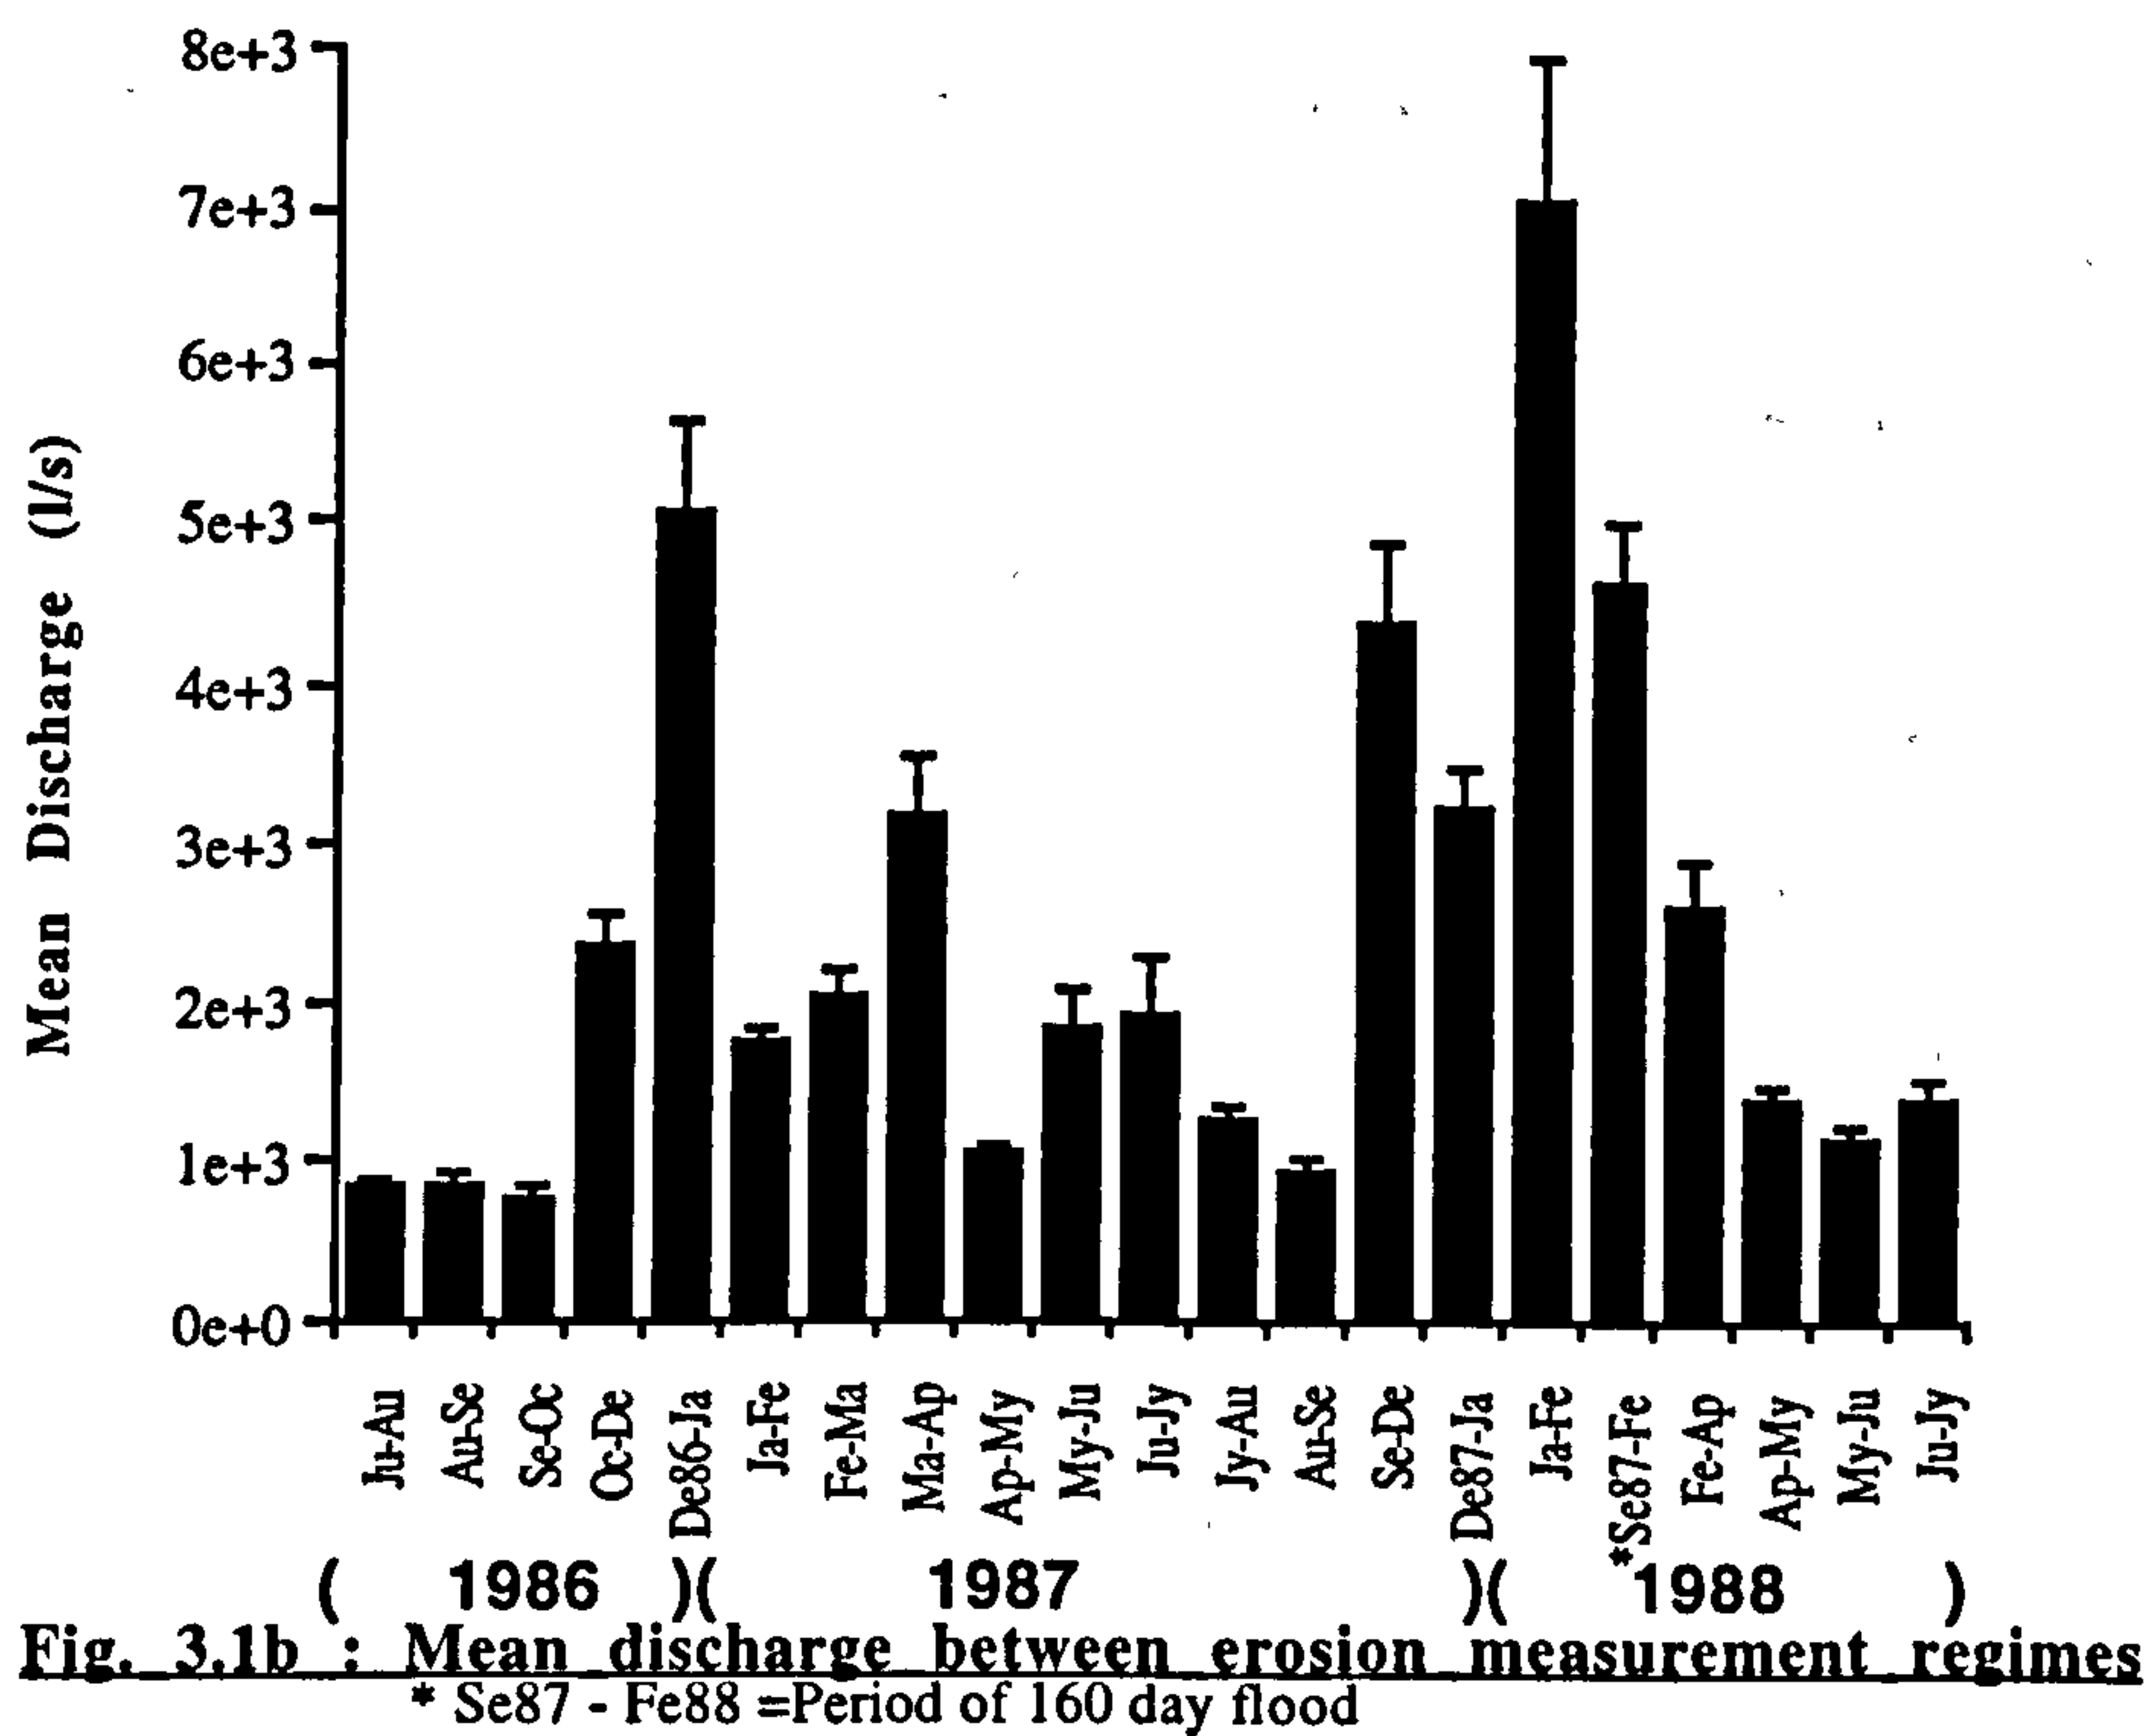
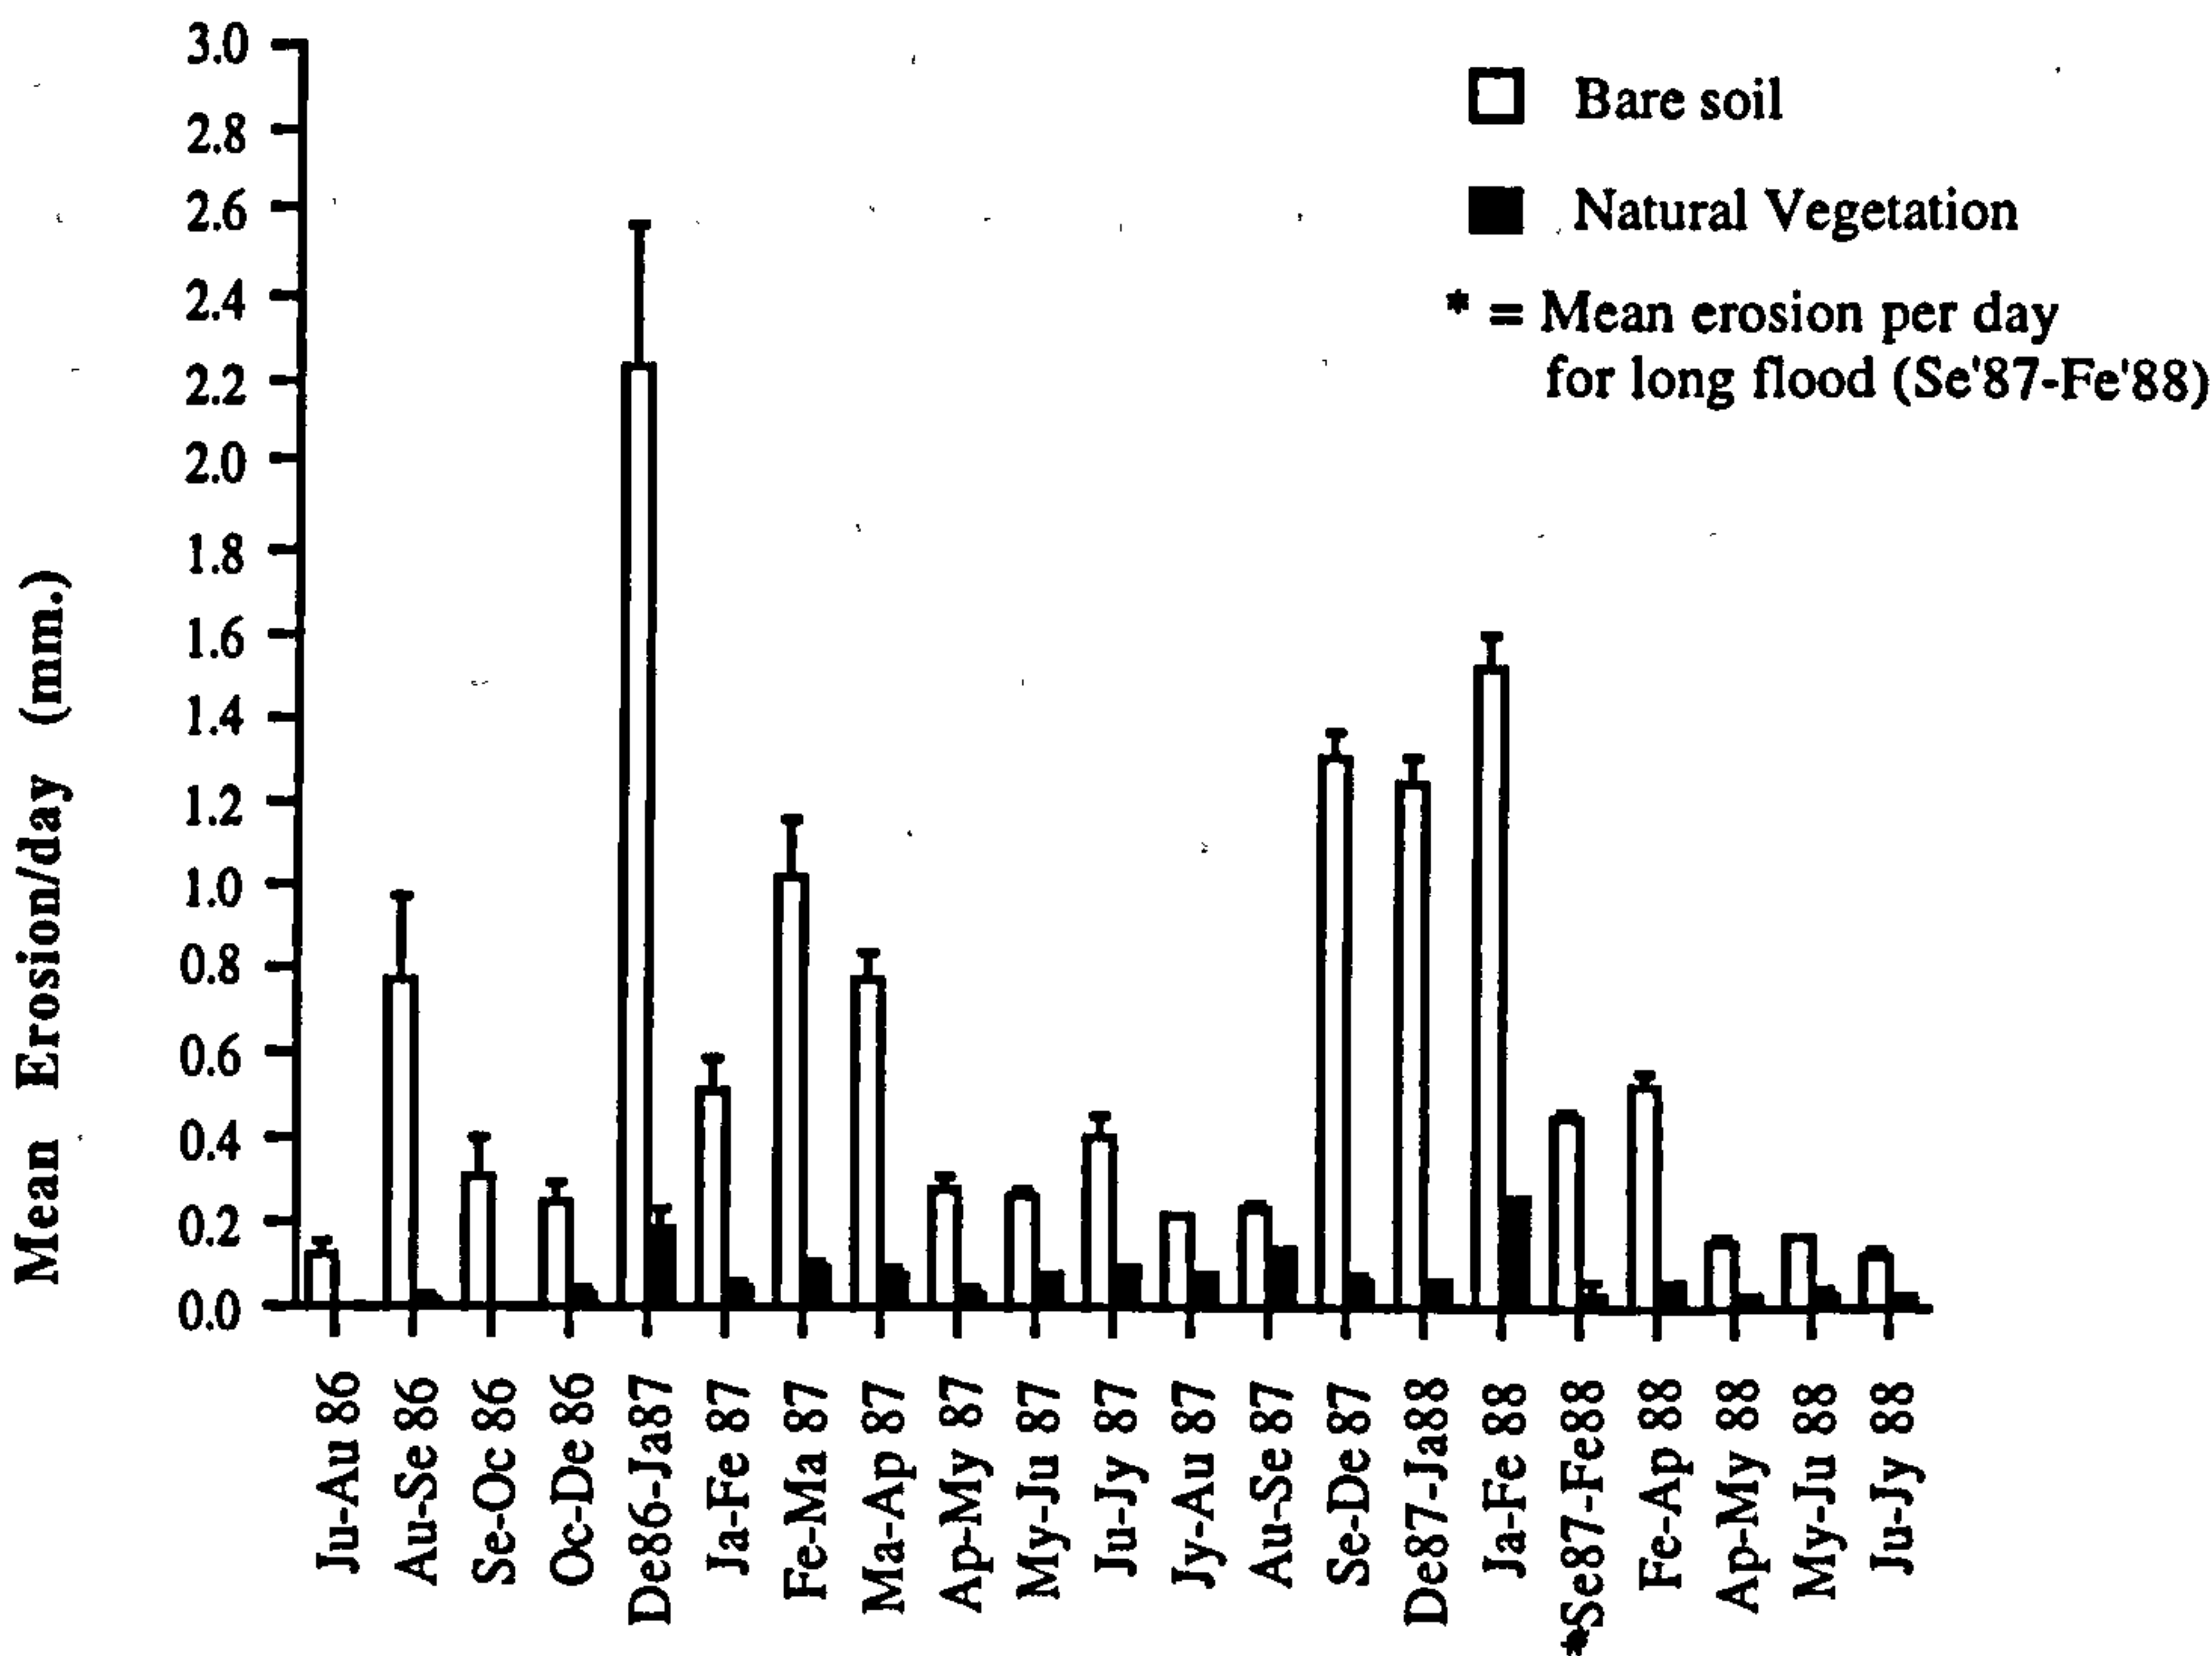
(six plots per treatment; mean erosion per day = average of recorded erosion of six plots (128 pin readings) / No. of days in erosion period; Error bars = Standard Error)

3.4.2a Comparison of erosion of Bare soil versus Naturally Vegetated Banks (whole banks)

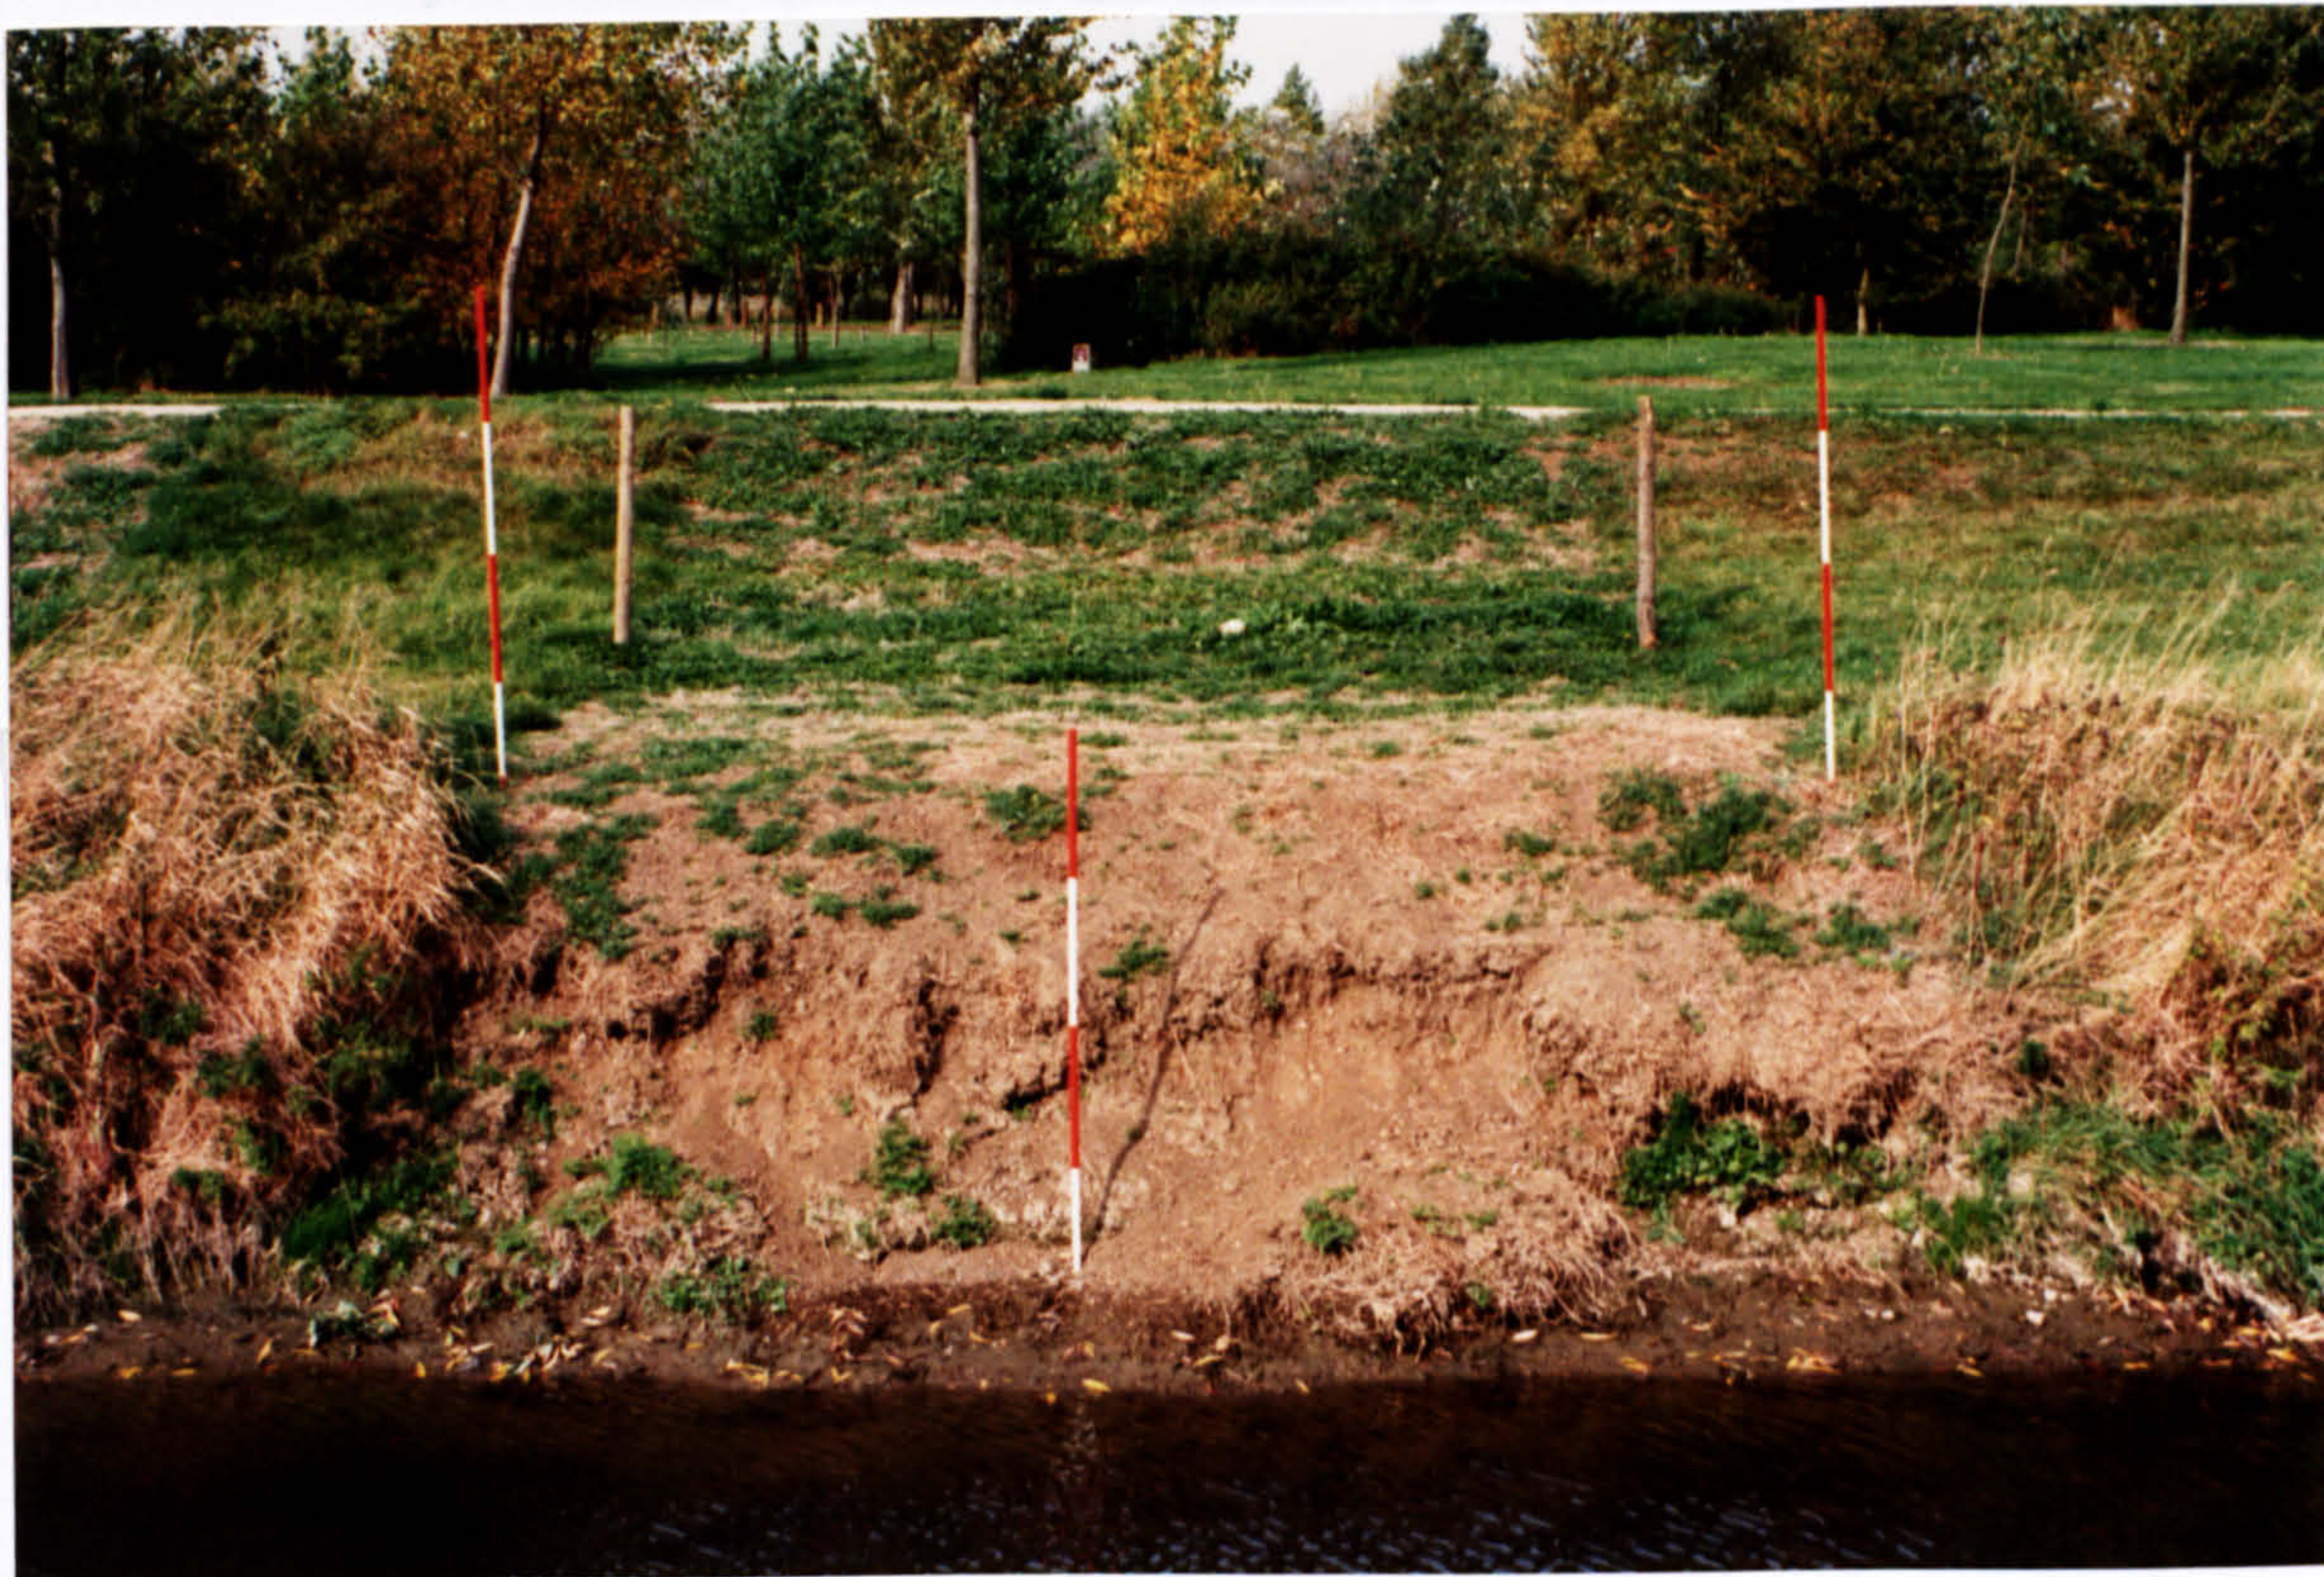
Plate 3. Bare bank in September 1986 (Plot 1b)

N.B. Lower & mid-bank failure after denudation with fast re-vegetating patches which needed spot herbicide application
